# Property Report

## Inspection and Recommendations

1234 N Camelback Road

Phoenix , AZ 12345

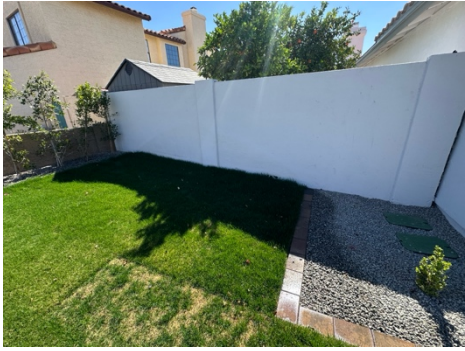
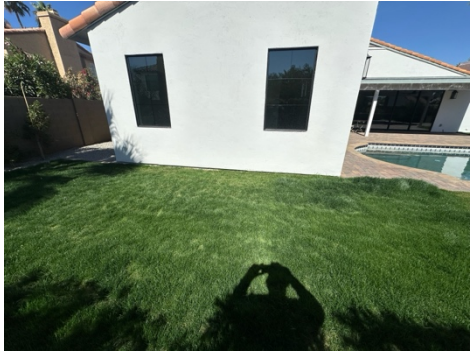
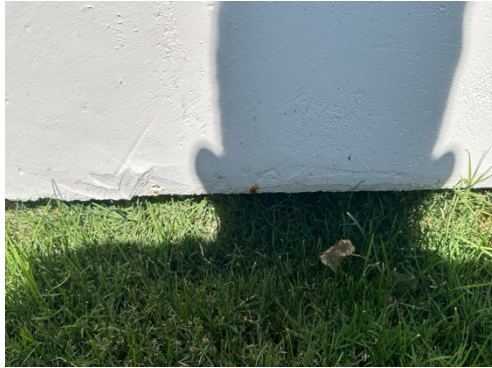
#### Problem 3: Water Damage

Description: There are certain areas where the grass is adjacent to the home and wall, and they are becoming wet due to the sprinkler system. This has started to cause water damage in some locations. Over time, it is likely that this problem will worsen.

Cause: The grass was planted too close to the house and walls.

Impact: The property may suffer from water damage and calcium stains on the walls and interior surfaces.

Recommendation: Move the grass 2 feet away from the house and wall. This will require relocating the sprinklers, removing a strip of grass, installing a new border, and filling the new area with gravel.

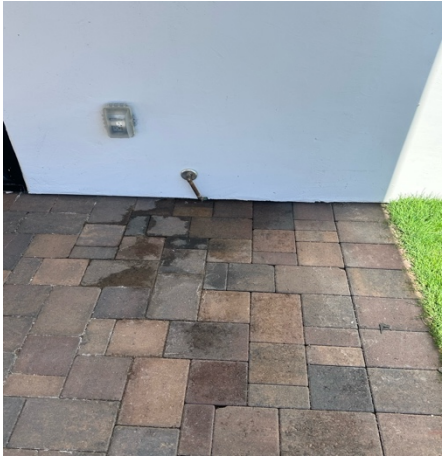
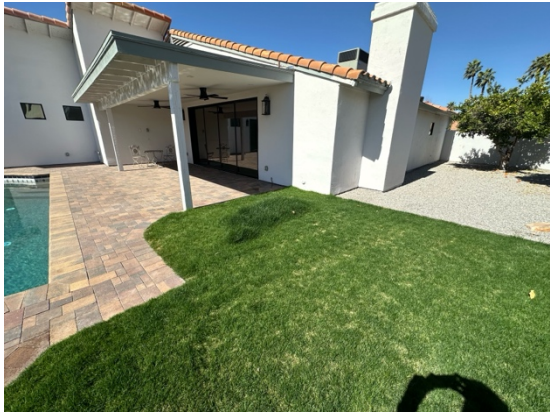
### Problem 4: Water Damage

Description: A copper drain is improperly draining onto the pavement instead of into the ground.

Impact: Calcium in water can stain pavers, and excess moisture may infiltrate the home through the wall.

Recommendation: Extend the drainage system to run off into an actual ground drain rather than on the paved surface.
